Gulco Marine Maintenance Superfund Site

Wetland Sediment Hot Spot
Remediation Meeting

May 17, 2010

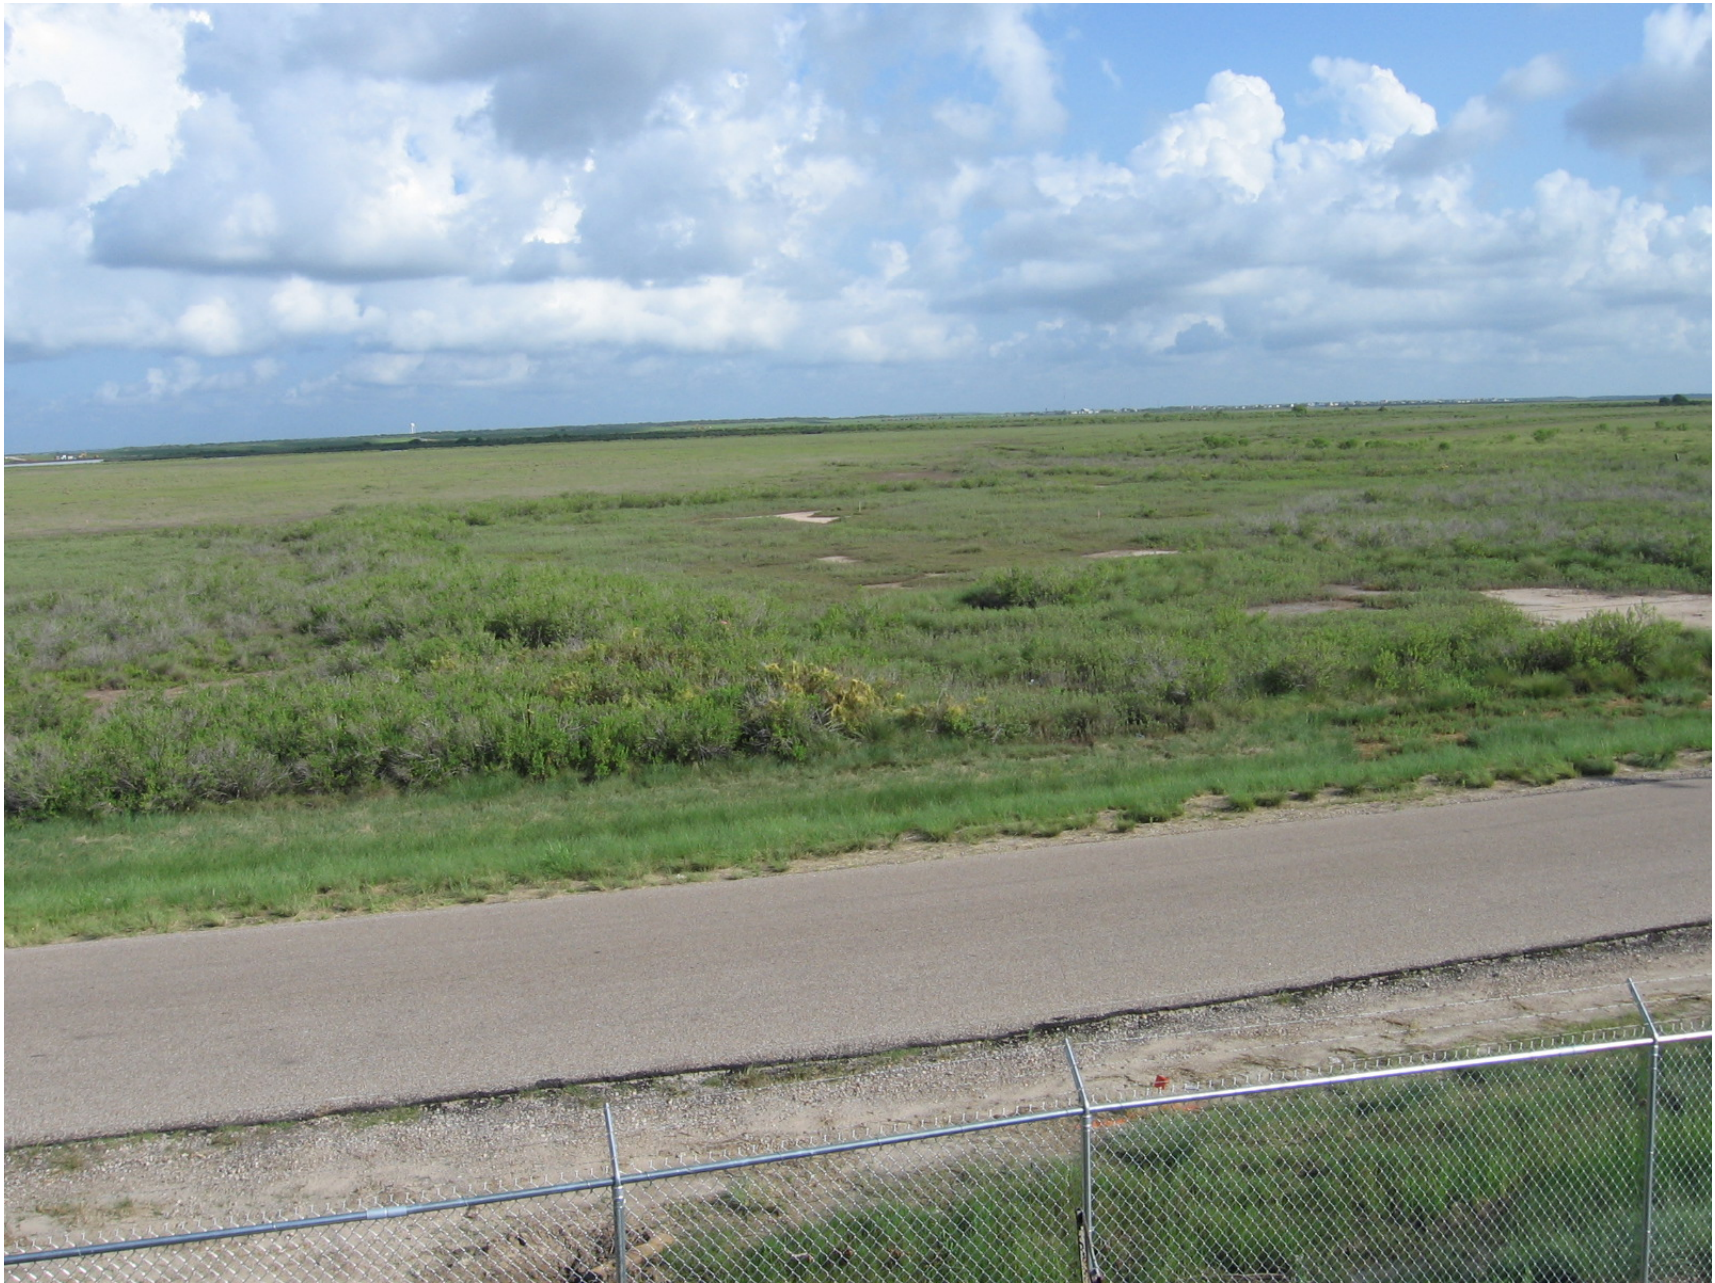
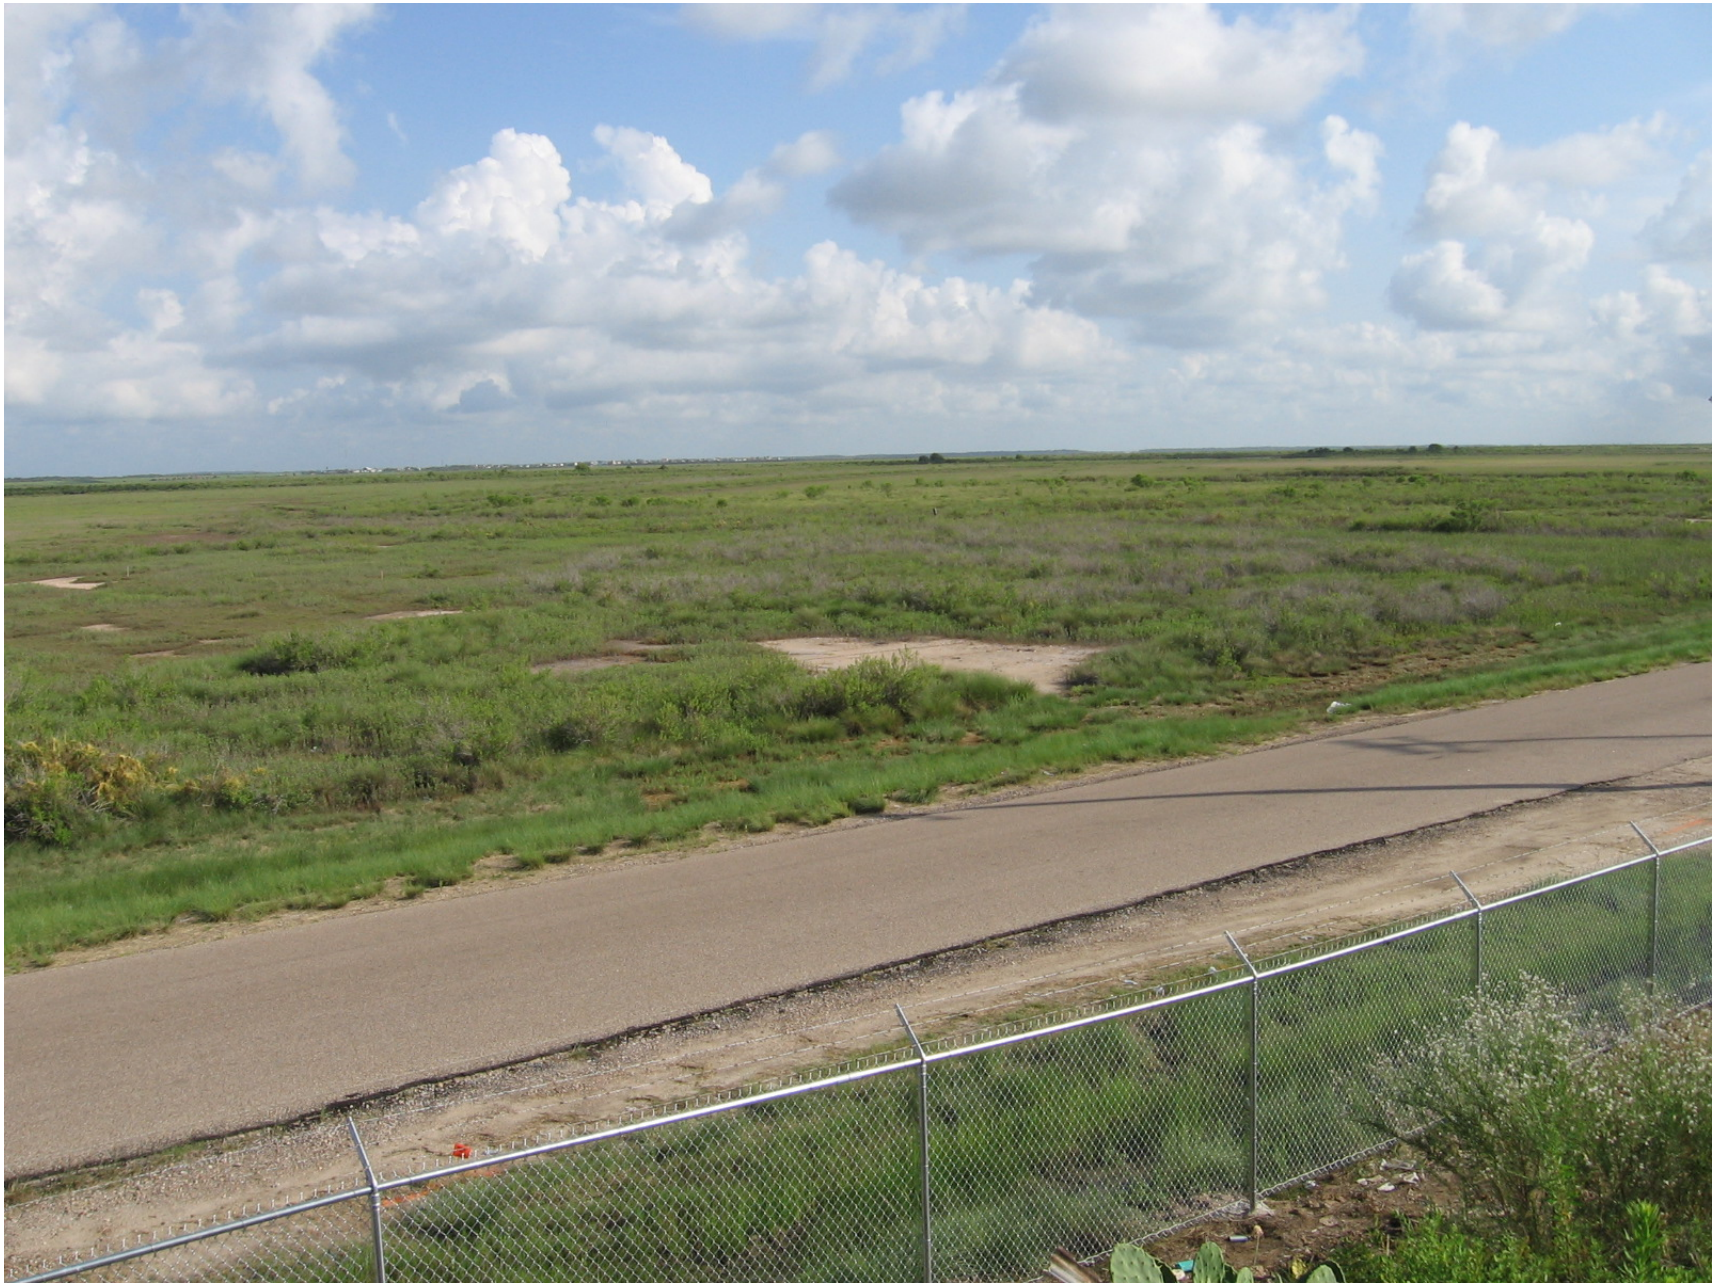
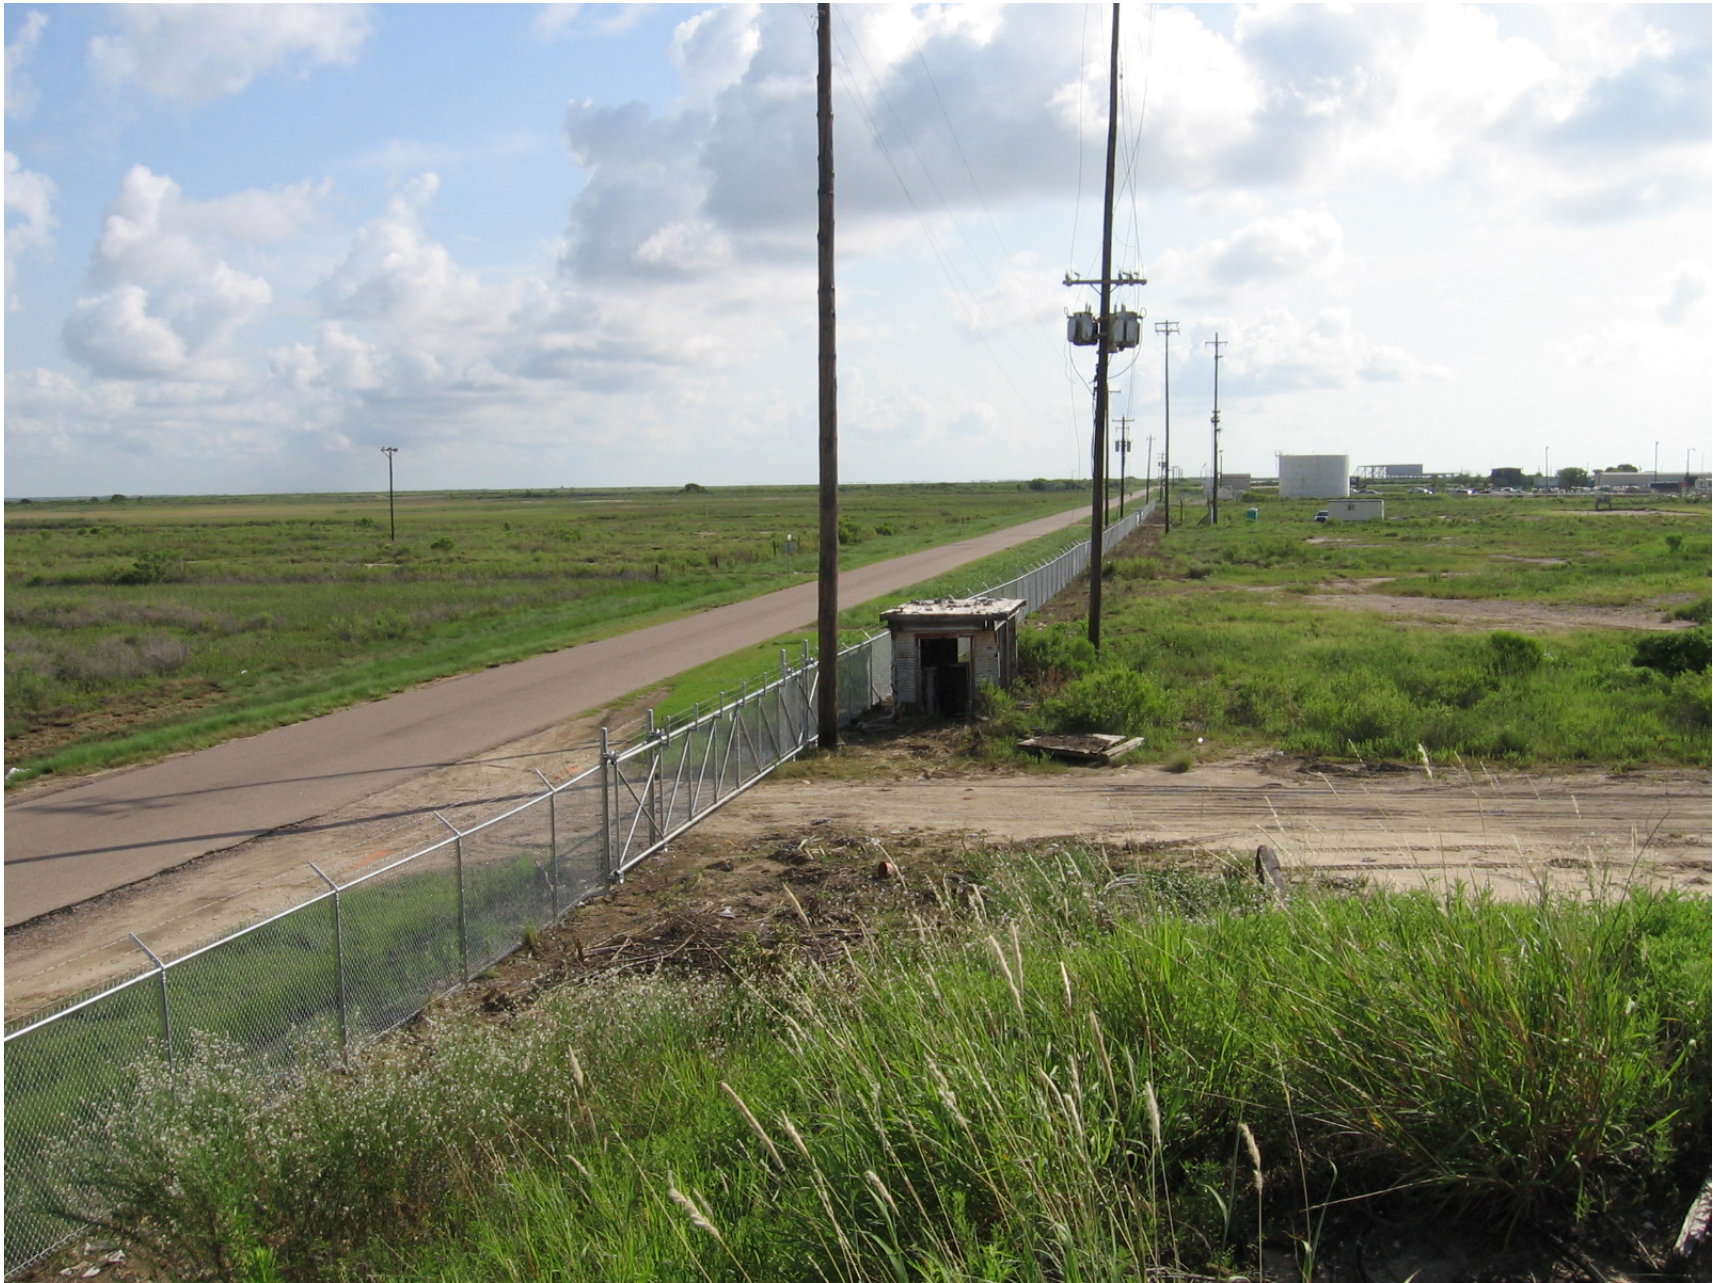
Figure 3
**DETECTED WETLAND SEDIMENT
CONCENTRATIONS EXCEEDING
ERL/ERM MIDPOINT AND PROPOSED
SEDIMENT HOT REMEDIATION AREA**

- Gulfco Marine Maintenance Site Boundary (approximate)
- Sediment Sample Location
- A Preliminary Proposed Sediment Hot Spot Remediation Area (Subject to Discussion in EPA Review Meeting)

1. Data Qualifiers: J = Estimated value.
J- = Estimated value, biased low.
2. BGS = below ground surface.
3. Total PAH concentrations were calculated using 1/2 of the sample detection limit as a proxy value for undetected PAHs.
4. Values shown on this figure exceed the midpoint of the ERL and ERM. Highlighted values exceed the ERM or AET.
- + Value exceeds Apparent Effects Threshold (AET). No ERL or ERM was available.

Depth (ft BGS)	Chemical of Interest	Conc. (mg/Kg)	ERL/ERM midpoint (mg/Kg)	ERM (mg/Kg)
0-0.5	Acenaphthylene	0.346J	0.342	0.64
0-0.5	Benzo(g,h,i)perylene	1.52	-	0.67+
0-0.5	Dibenz(a,h)anthracene	2.83	0.162	0.26
0-0.5	Indeno(1,2,3-cd)pyrene	1.59	-	0.6+
0-0.5	Total HPAH	10.392	5.65	9.6

Depth (ft BGS)	Chemical of Interest	Conc. (mg/Kg)	ERL/ERM midpoint (mg/Kg)	ERM (mg/Kg)
0-0.5	Acenaphthylene	0.545J	0.342	0.64
0-0.5	Benzo(g,h,i)perylene	1.94	-	0.67+
0-0.5	Chrysene	4.05	1.59	2.8
0-0.5	Dibenz(a,h)anthracene	2.91	0.162	0.26
0-0.5	Indeno(1,2,3-cd)pyrene	1.94	-	0.6+
0-0.5	Total HPAH	13.931	5.65	9.6

Depth (ft BGS)	Chemical of Interest	Conc. (mg/Kg)	ERL/ERM midpoint (mg/Kg)	ERM (mg/Kg)
0-0.5	Benzo(a)anthracene	0.993	0.93	1.6
0-0.5	Benzo(a)pyrene	1.3J	1.02	1.6
0-0.5	Benzo(g,h,i)perylene	0.862J-	-	0.67+
0-0.5	Dibenz(a,h)anthracene	0.337J-	0.162	0.26
0-0.5	Indeno(1,2,3-cd)pyrene	1.1	-	0.6+
0-0.5	Phenanthrene	1.3	0.87	1.5
0-0.5	Pyrene	1.64J-	1.63	2.6
0-0.5	Zinc	601	280	410
0-0.5	Total HPAH	11.762	5.65	9.6

- Preliminary Proposed Areas in April 29 Work Plan
 - Areas A and B northeast of former surface impoundments
 - Area C immediately north of Marlin Ave
- GIS/Database Query (“rubber band”) Evaluation

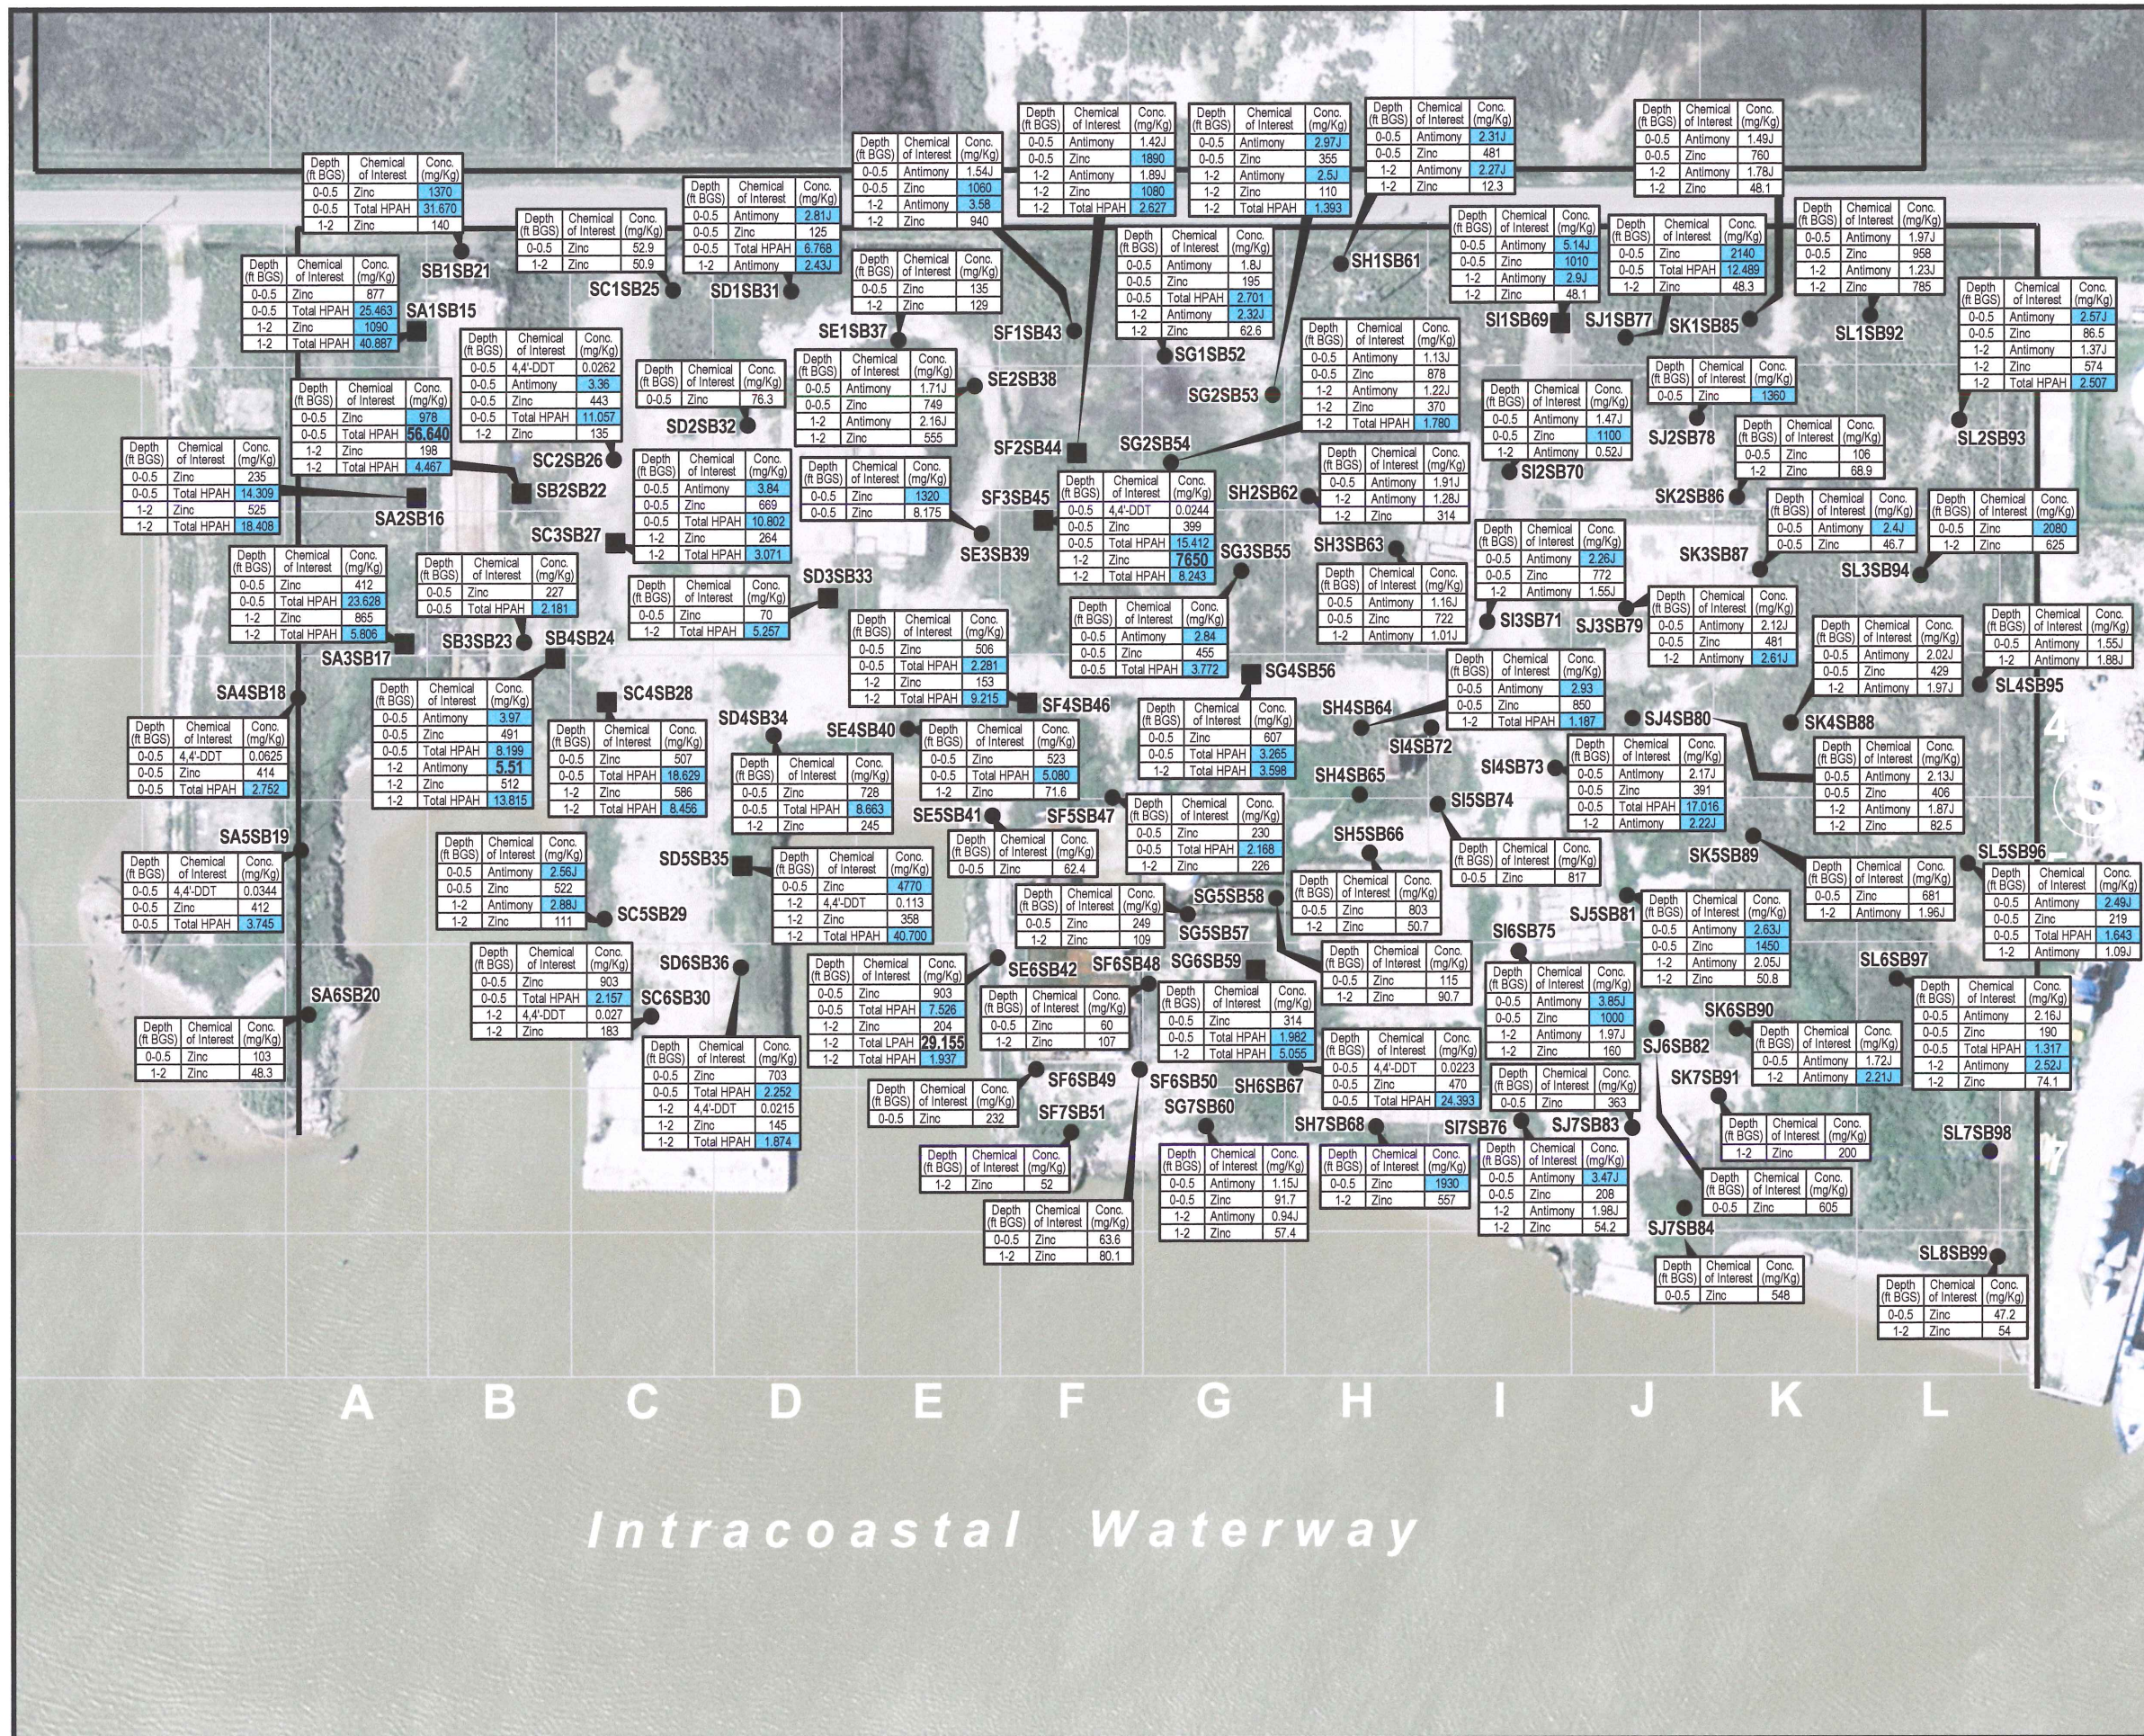
Figure 6A
**DETECTED CONCENTRATIONS
EXCEEDING ECOLOGICAL SCREENING
LEVELS FOR SOIL INVERTEBRATES*
- SOUTH AREA SOIL**

1. Data Qualifier: J = Estimated value.
2. BGS = below ground surface.
3. Light blue highlighted values are higher than maximum background concentrations (See Figure 8 for background soil data).
4. Bold values are the maximum measured concentration for that compound.

* The compounds shown in the figure are the compounds that were detected at a concentration greater than the screening level (See Tables 1 & 2). The screening levels are:
Antimony - 0.27 mg/kg
4,4'-DDT - 0.021 mg/kg
Zinc - 46 mg/kg
Total LPAH - 29 mg/Kg
Total HPAH - 1.1 mg/Kg

- No higher trophic level receptor HQs >1
- Restrictive covenant for commercial/industrial land use only
- Much of South Area highly disturbed (dry dock, driveways, slabs, etc.)
- Areas of non-metal screening levels exceedences associated with engineered fill (dry dock, driveways)

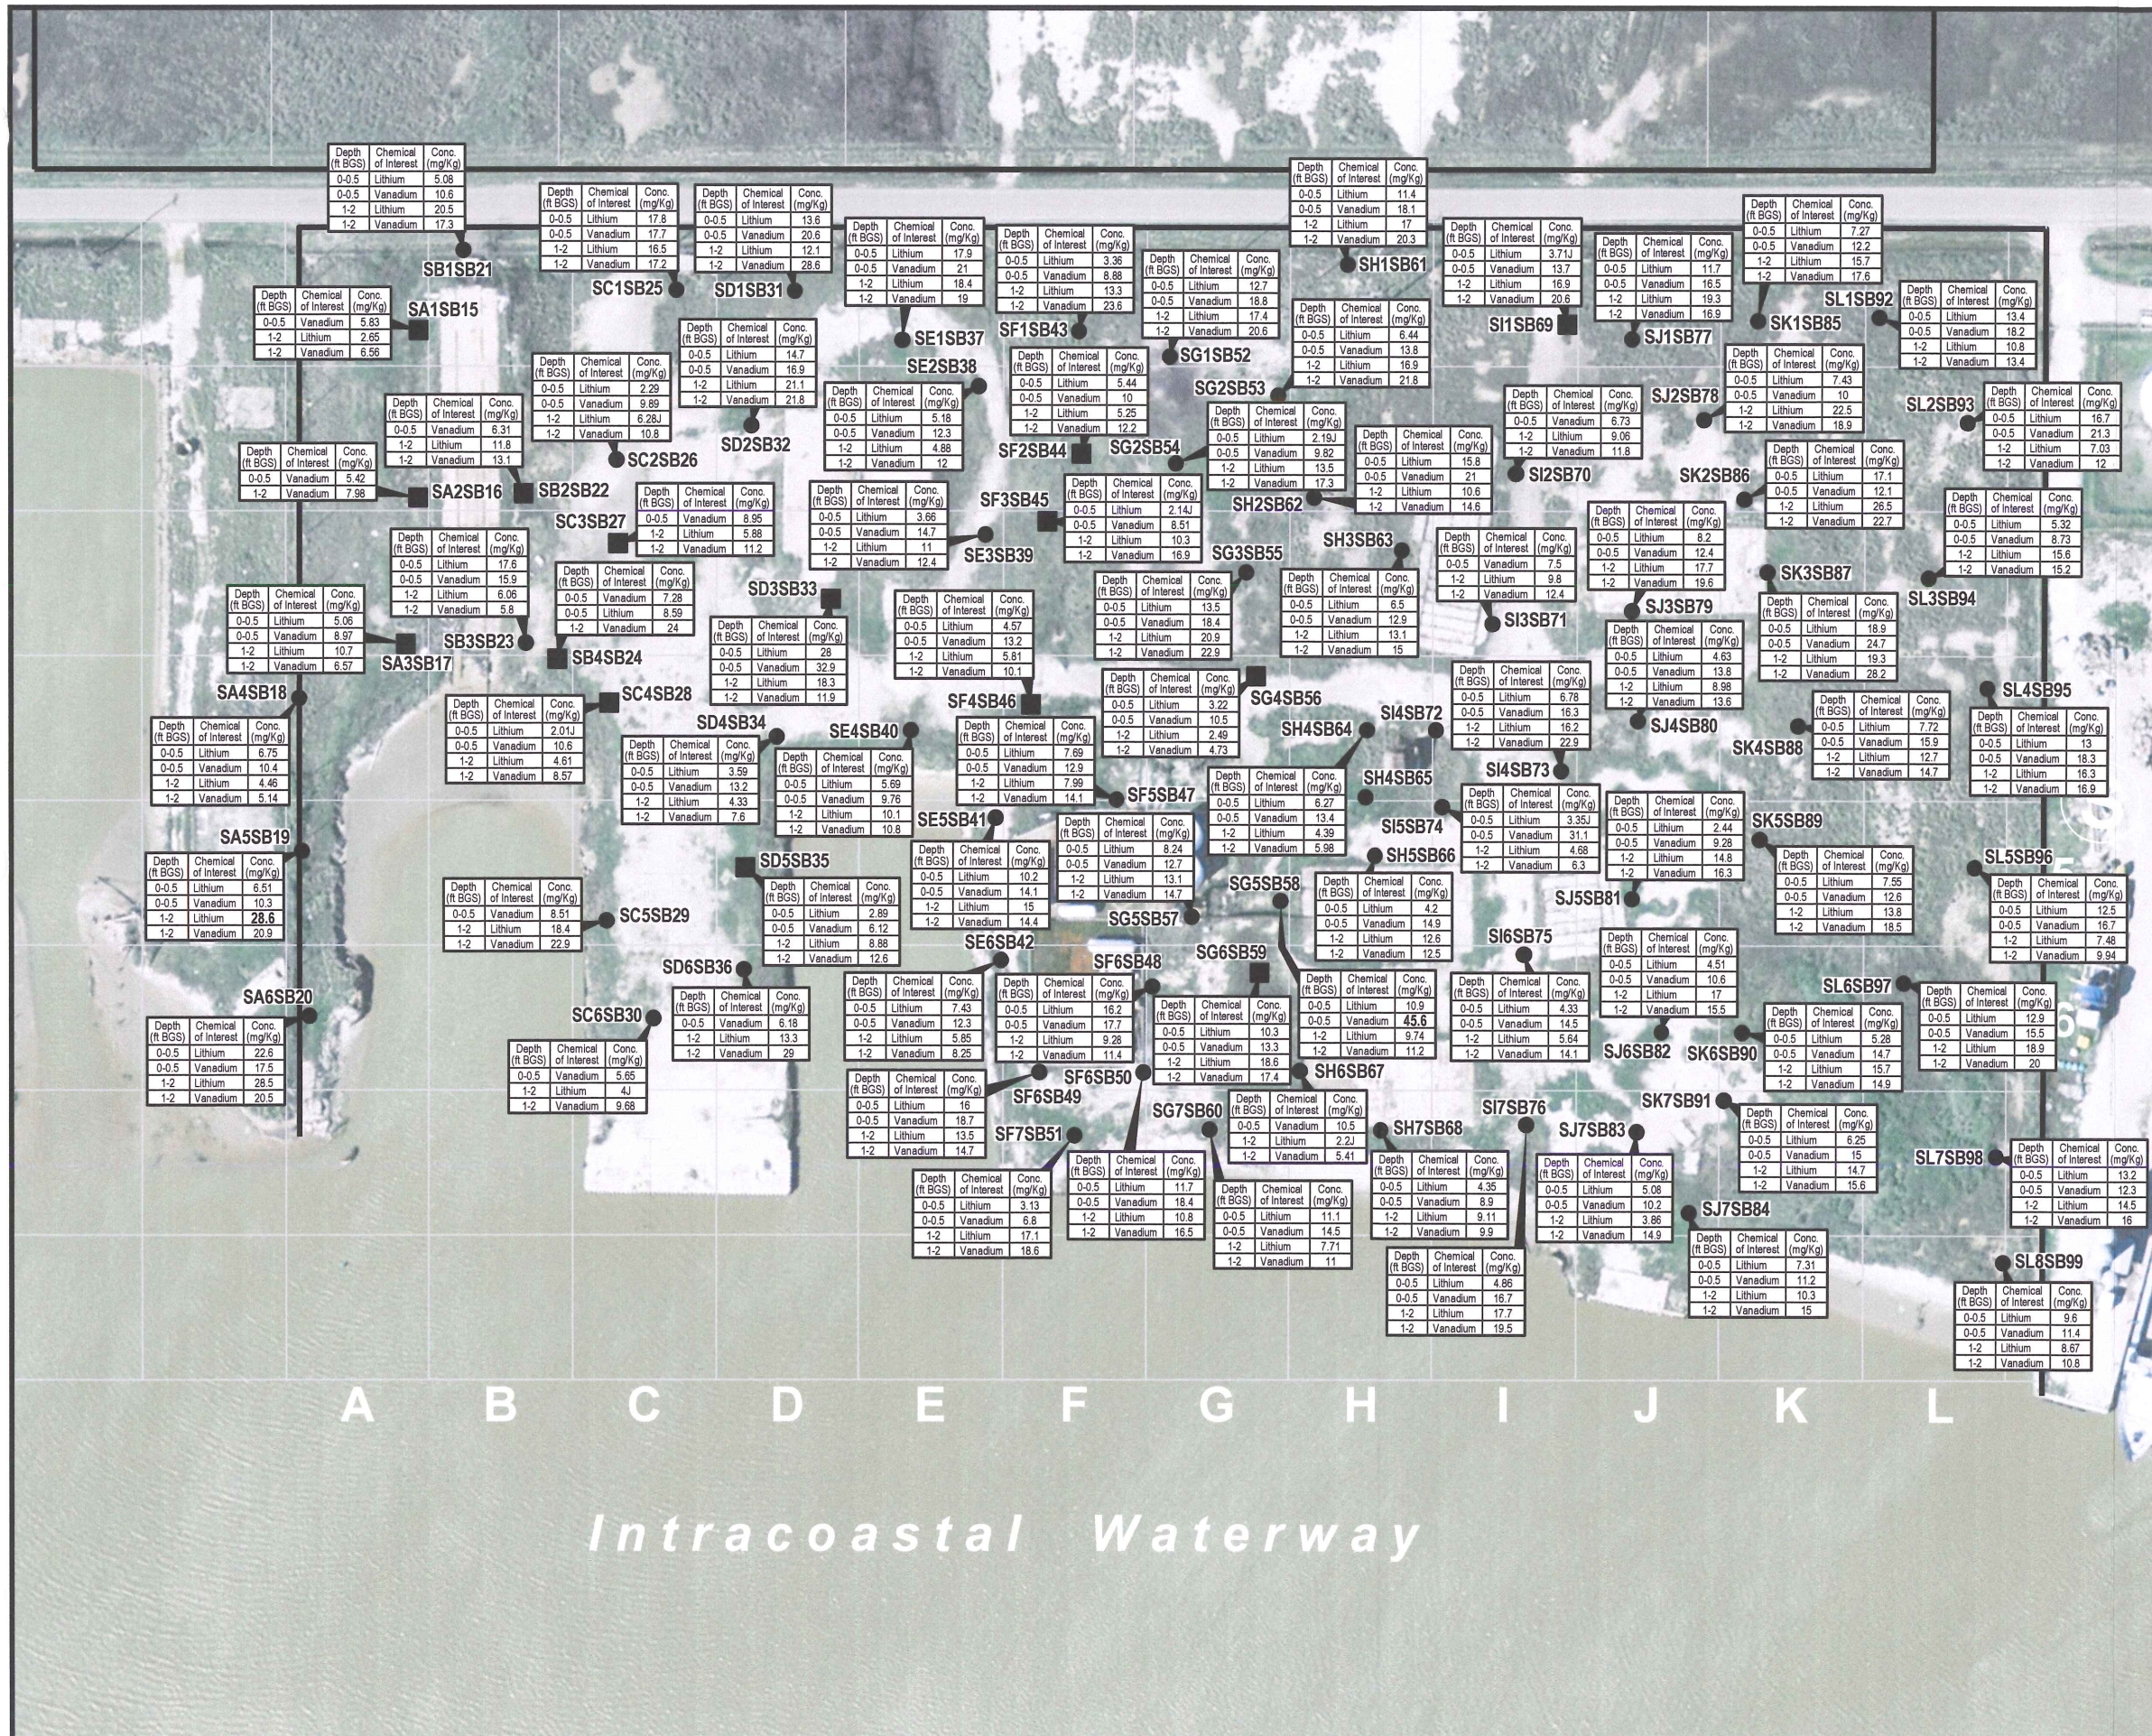
Figure 6D DETECTED CONCENTRATIONS EXCEEDING ECOLOGICAL SCREENING LEVELS FOR SOIL INVERTEBRATES* - SOUTH AREA SOIL

Notes:
1. Data Qualifiers: J = Estimated value.
J- = Estimated value, biased low.
2. BGS = below ground surface.
3. Bold values are the maximum measured concentration for that compound.
* The compounds shown in the figure are the compounds that were detected at a concentration greater than the screening level (See Tables 1 & 2).
The screening levels are:
Lithium - 2 mg/Kg
Vanadium - 2 mg/Kg

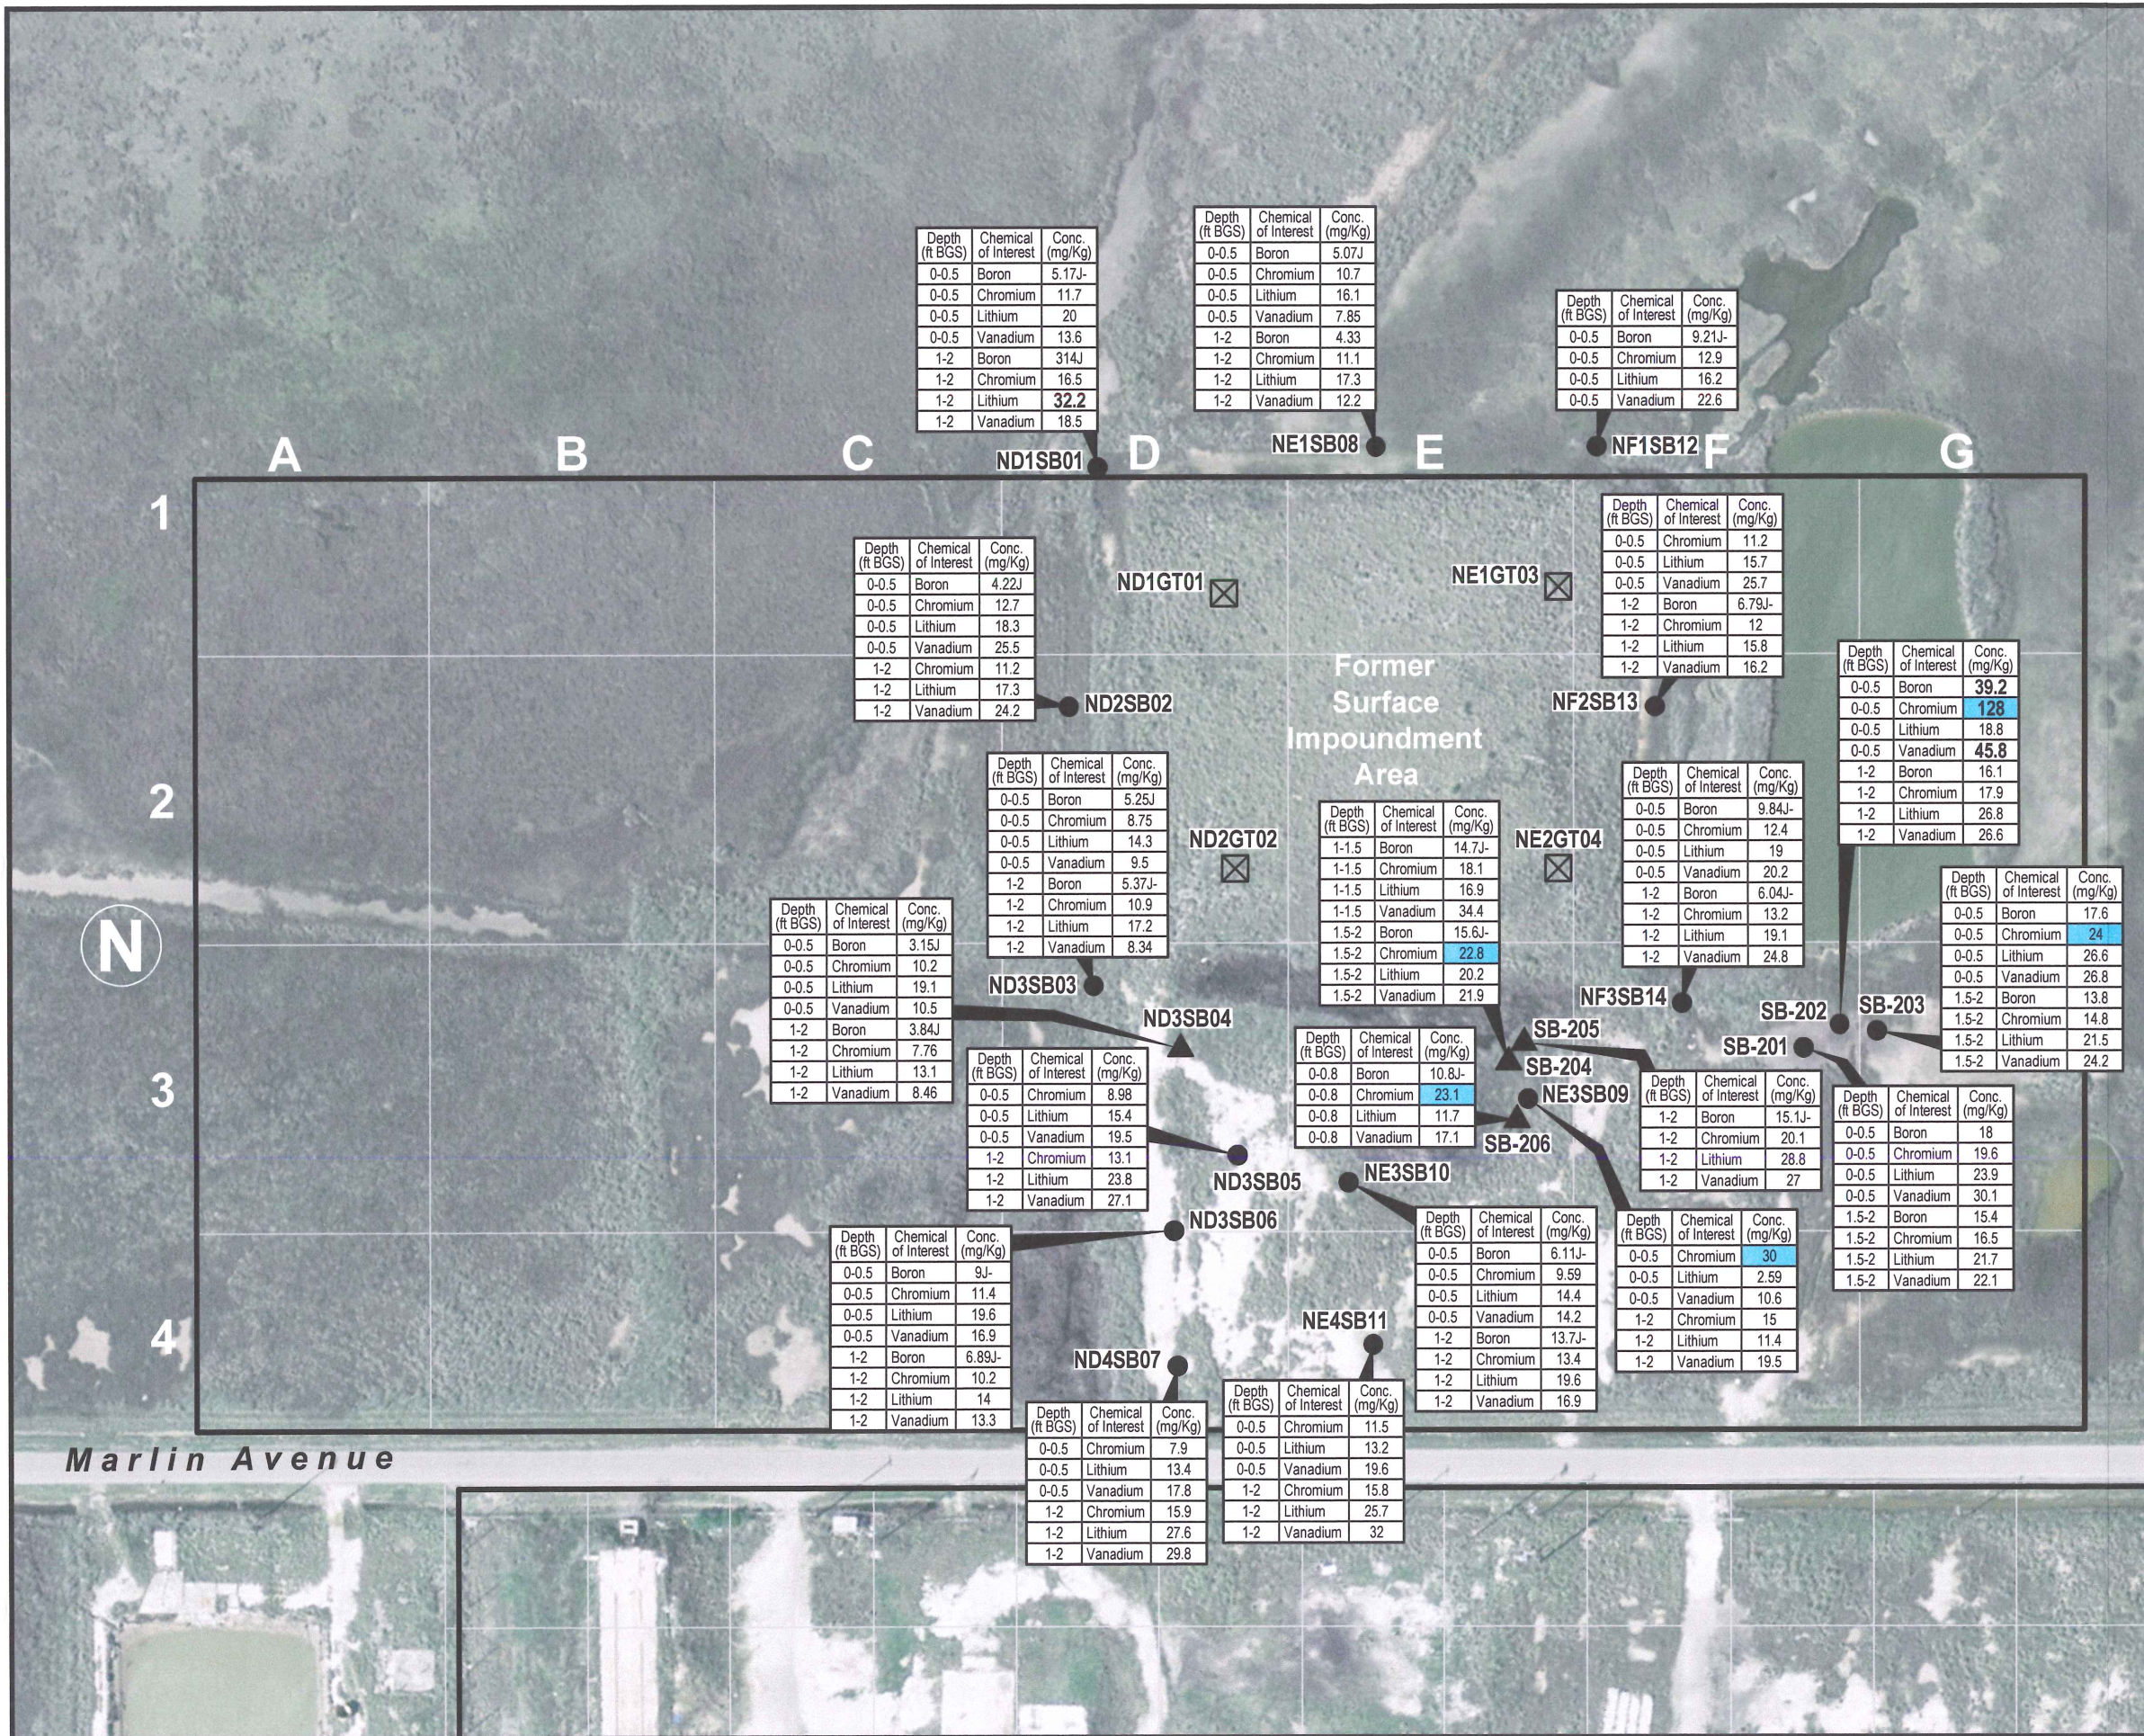
Figure 7B
**DETECTED CONCENTRATIONS
EXCEEDING ECOLOGICAL SCREENING
LEVELS FOR SOIL INVERTEBRATES*
- NORTH AREA SOIL**

* The compounds shown in the figure are the compounds that were detected at a concentration greater than the screening level (See Tables 3 & 4).

The screening levels are:
Boron - 0.5 mg/Kg
Chromium - 0.4 mg/Kg
Lithium - 2 mg/Kg
Vanadium - 2 mg/Kg

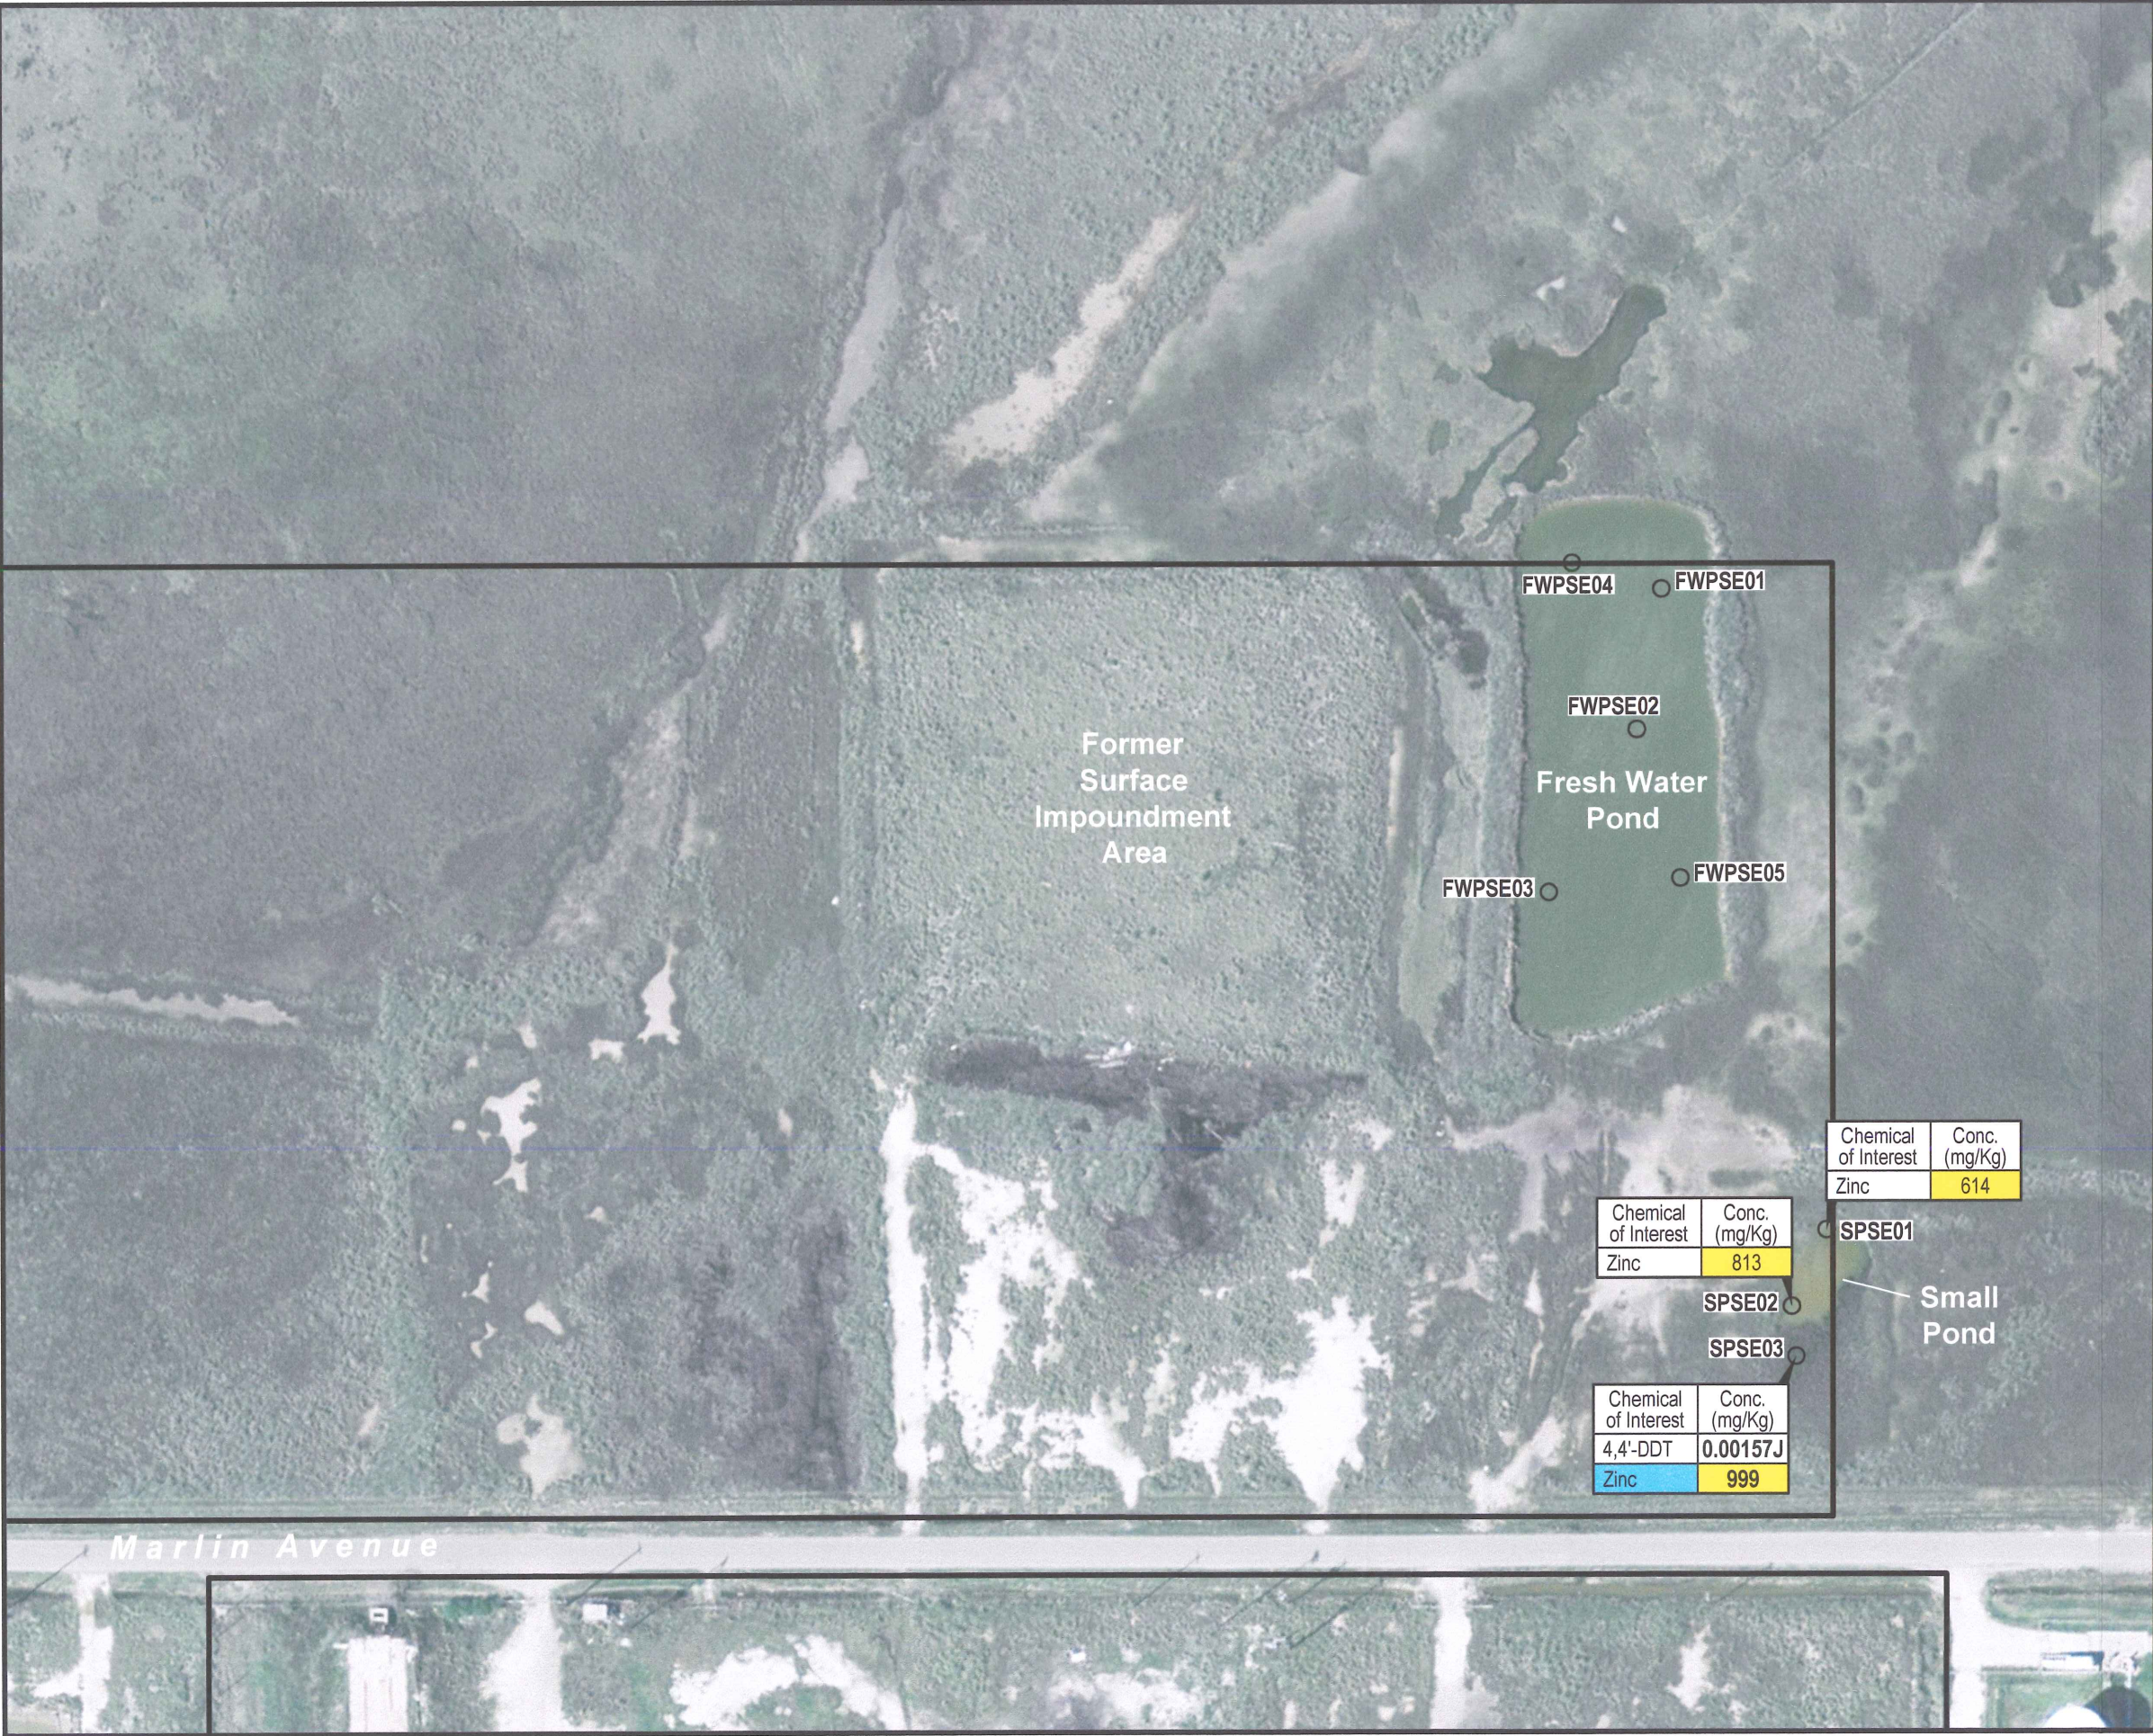
Figure 12
**DETECTED CONCENTRATIONS
EXCEEDING ECOLOGICAL SCREENING
LEVELS FOR BENTHIC INVERTEBRATES*
- PONDS SEDIMENT**

Notes:
1. All samples from 0-0.5 ft depth interval.
2. Data Qualifiers: J = Estimated value.
3. Bolded values are the maximum measured concentration for that compound.
4. Light blue highlighted values are higher than maximum background concentrations (See Figure 8 for soil background data).
* Values shown in the figure exceed the Effects Range Low (ERL) (See Table 9). Yellow highlighted values exceed the midpoint of the ERL and Effects Range Medium (ERM).
The ERLs are:
4,4'-DDT - 0.0012 mg/kg
Zinc - 150 mg/kg

- No upper trophic level receptor HQs >1
- Only ERL-ERM midpoint exceedences are zinc in Small Pond samples
- 2 of 3 Small Pond zinc concentrations below background maximum (3rd is 999 mg/kg; background max is 969 mg/kg)
